Battersea Power Station (Apple HQ) London, UK

OVERVIEW

Stravifloor Channel

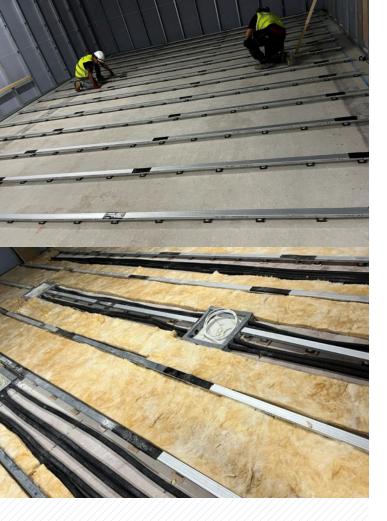
- Isolated steel batten system for the support of concrete floating floor applications, using strong, galvanized steel channels over the springs
- Uses steel channels to facilitate the positioning of the optimized discrete supports, allowing fewer contact points (transmission paths) to the subfloor

221m² of Stravifloor Channel, a resilient high-performance floating floor based on floor channels containing steel springs as resilient supports was installed to decouple the acoustically critical listening, screening and control room spaces at Battersea Power Station.

The added insulation material between the channels contributes to the acoustic optimization of the spaces by preventing the so-called standing wave effect to take place within the air void.

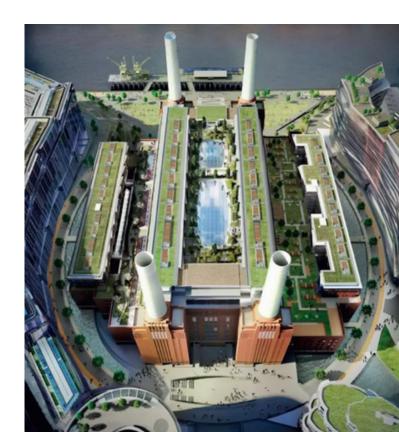
221 m² Stravifloor Channel

During the installation of the acoustic floating floor, careful attention was paid to the many service penetrations as improper installation would most certainly lead to rigid connection which in turn affect the system's performance.
